ARINC Research Publication 2315-11-1-2635

**FINAL ENGINEERING REPORT
IMPROVEMENT PROGRAM FOR THE
C-141 NAVIGATION SELECTOR PANEL**

January 1982

**Prepared for
RELIABILITY ENGINEERING BRANCH
ITEM MANAGEMENT DIVISION
MMIRCA-4
ROBINS AIR FORCE BASE, GEORGIA 31098
under Contract F09603-80-G-3338-0012**

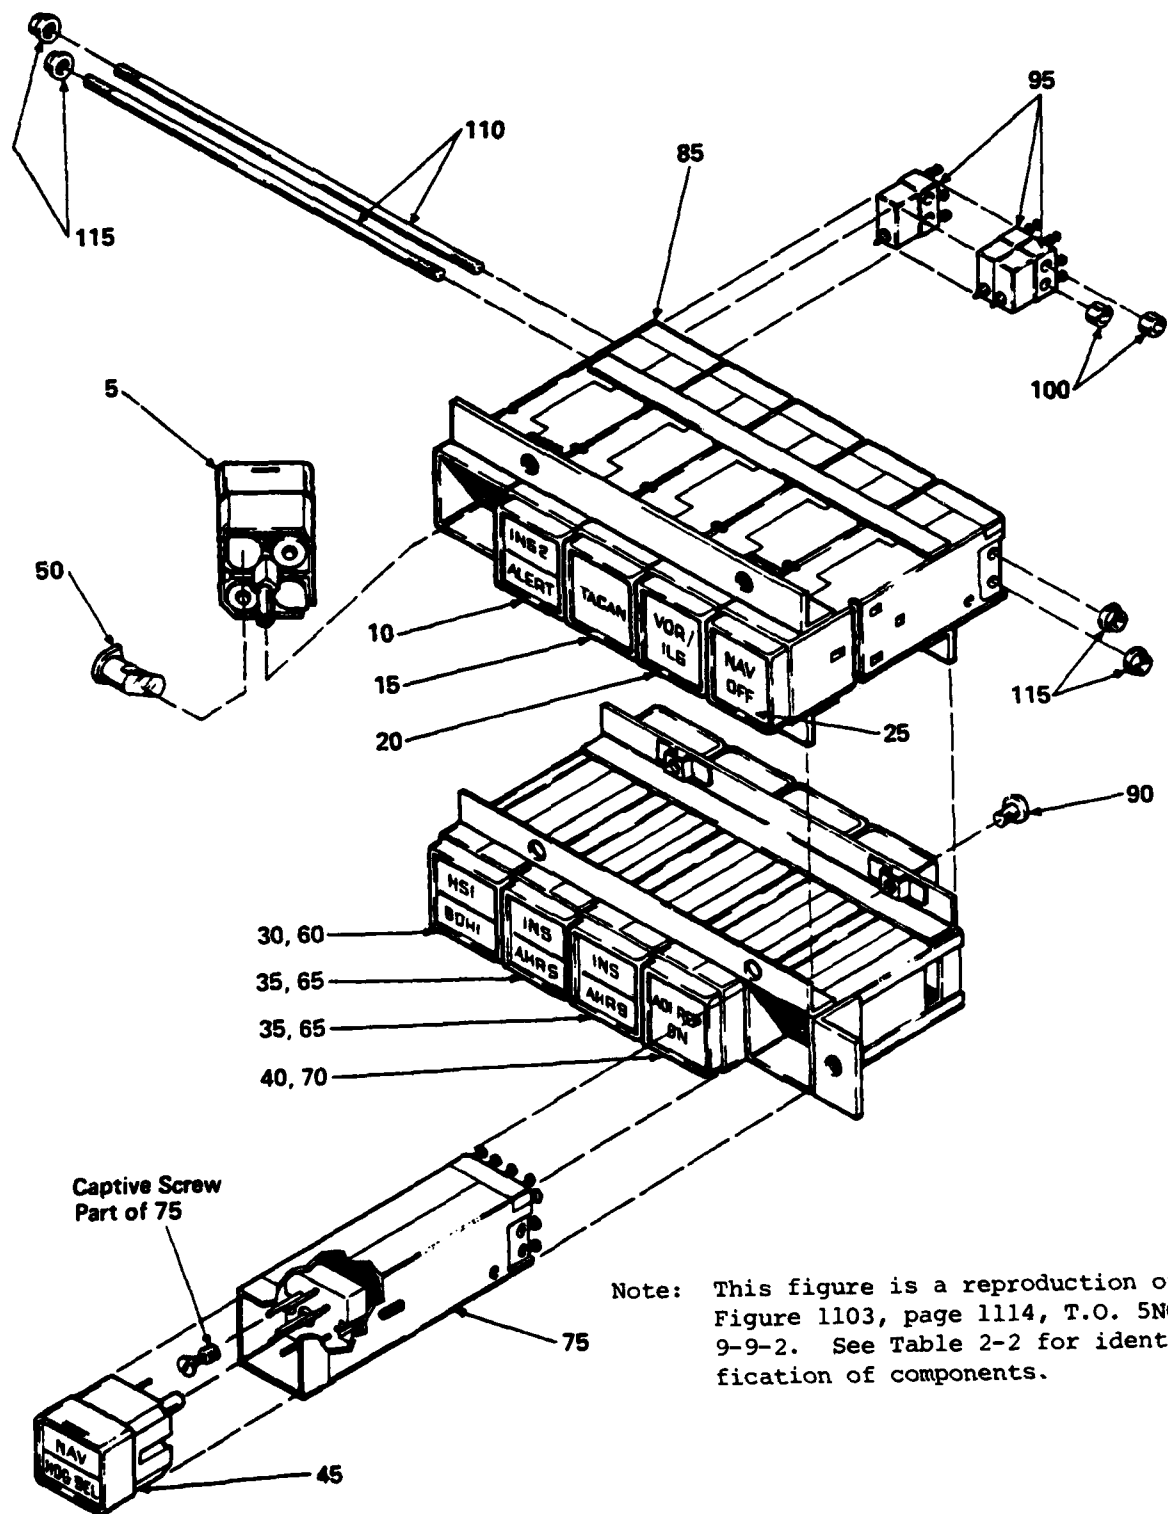
Figure 2-1. SWITCH ASSEMBLY

Maintenance was made more difficult and more expensive because the top row of interlocked switches (see No. 85 in Figure 2-1) were spot-welded together as required by the design of the mechanical interlock mechanism. As a result, if one of the switches failed, all five had to be discarded and a new assembly of five used to replace them. The assembly is not a repairable item and represents a considerable loss when discarded. In addition, the replacement of the assembly requires a considerable expenditure of time because 23 solder terminals must be disconnected and reconnected, some terminating more than one wire. As a result of these examinations, it was readily apparent that a replacement for the present switch assembly was needed.

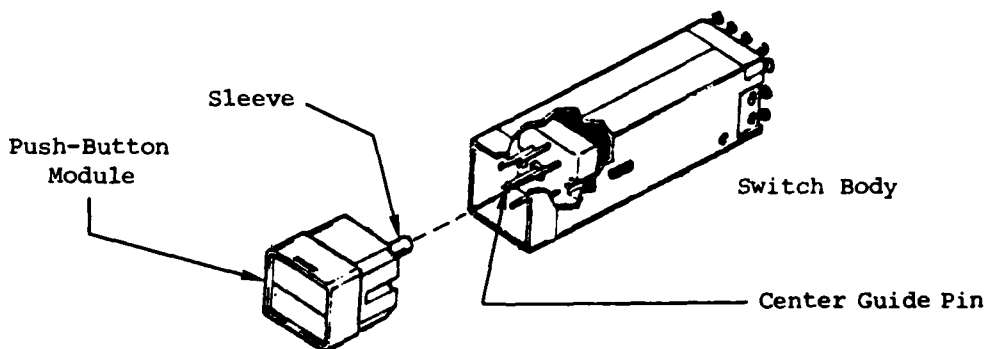
Figure 2-2. PRESENT SWITCH

A major problem can occur with this switch. The sleeve on the push-button module fits over the center pin in the switch body (see Figure 2-2) and is designed so that it snaps into place and is retained to the switch body by a ridge on the guide pin (see Figure 2-3). The dimensions of the push-button module, its sleeve, the switch body and its center guide pin are such that the module must be precisely aligned before any attempt is made to seat it. If not properly aligned, the sleeve does not fit over the pin but, instead, will slide alongside and will bend the guide pin as the module is pressed into the switch body. Eleven of the 20 guide pins in the assemblies examined were bent to some degree and two of them to such a degree that the push-button module could not be inserted into the switch body. There was one case of the sleeve being broken off the module and one case of the module being jammed into the switch body so that it could not be extracted. Both of these situations probably resulted from misalignment of the sleeve and guide pin.

We also discovered that the center guide pin could be bent so that contact was made with the lamp contacts, which could easily cause a short in a lamp circuit. This, in turn, could cause a component failure on the circuit board due to excessive current through the diodes and resistors. Although it was not possible to prove, it is speculated that this situation may have been a cause for some of the circuit board failures reported.

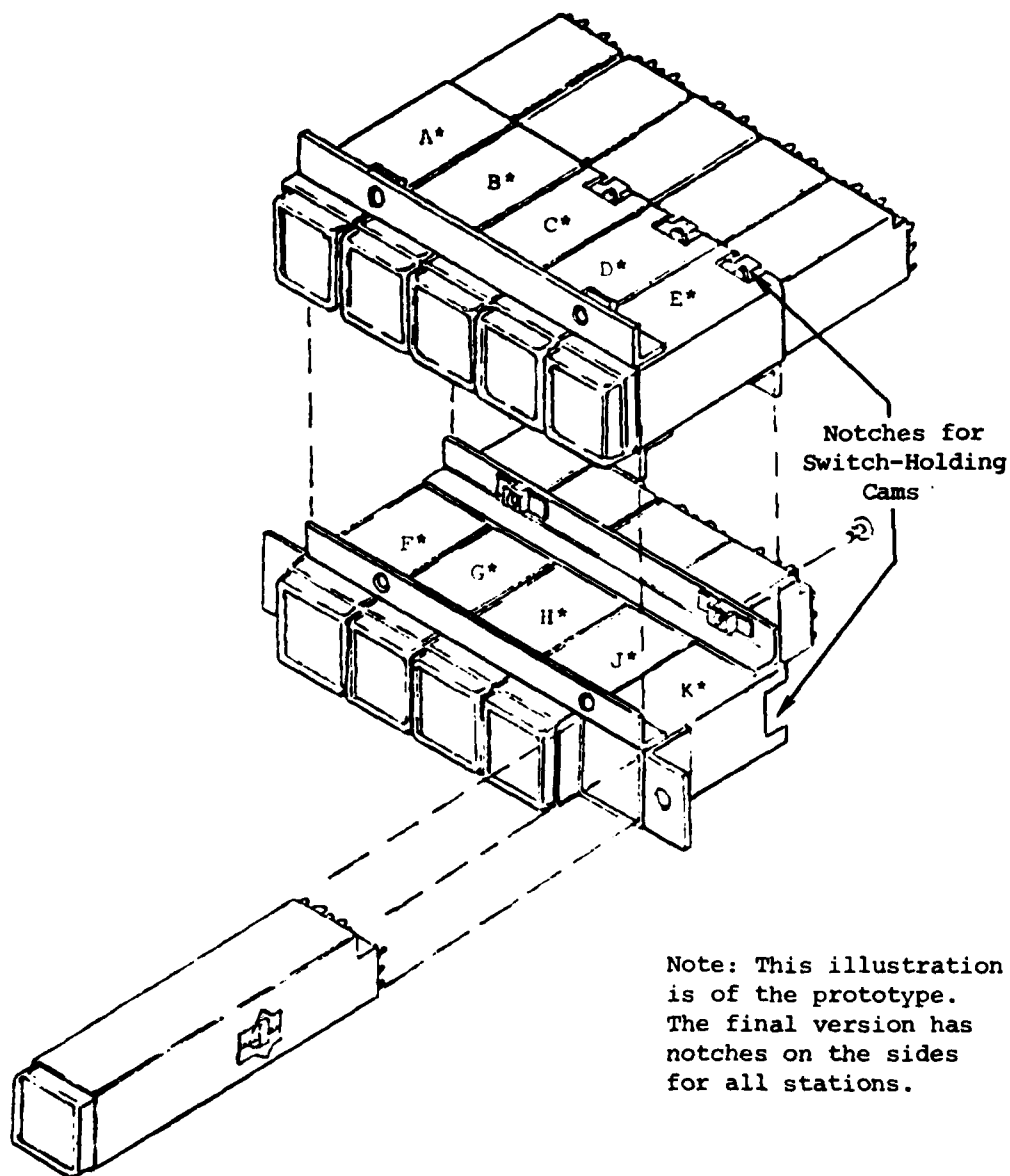
Figure 2-4. SWITCH ASSEMBLY AND STATION LOCATIONS

The two switch assemblies and NSPs were completely assembled following delivery of the second order, and arrangements were made to take them to McGuire AFB for testing on the CUT using the test procedures in T.O. 5N6-9-9-2. The tests were conducted by Mr. H. Riser of ARINC Research Corporation and Mr. J. Tye of WR-ALC on December 9. During the course of the test, one switch was found to be defective and was replaced with a spare. Another problem occurred when a lamp circuit in one of the switches was short-circuited. Displaced insulation on one of the lamp terminals on the switch was the cause. The insulation was replaced and both panels operated properly. The legends on three modules, stations C, D, and E in Figure 2-4 (see item numbers 15, 20, and 25 on Figure 2-1), were rotated 90 degrees clockwise because of a mistake in ordering. When the orders were initially prepared, we mistakenly believed that a certain legend style was needed that required that the switch body be rotated 90 degrees.

It did not have to be. The design of the upper housing bracket has been corrected to allow proper installation of the switch bodies. Figure 2-4 shows the rotation of the switches as they were assembled. Compare the notches for the switch holding cams in Station E with Station K. All should be like Station K.

The selection of the Jay-El switch also determined the hardware requirements. A new switch housing bracket was designed to accommodate the switches and fabrication was ordered (see Figure 2-4 for new switch assembly design). The Jay-El switches were also ordered (see paragraph 2.2.3 for a discussion of the fabrication and assembly actions).
